A Quick Repair Approach to Damaged Roads in West Malaysia.

Truck overloading is the main cause of road damages in this region. Overloading is rampant; with 90% of the trucks plying our roads being overloaded to two (2) times or more, than the permissible loads. As a matter of fact, our roads get damaged faster than we can ever repair them; ever mindful of the relation between road damages (by overloaded vehicle axles) to the legal and permissible vehicle axle loads is to the power of four. Besides overloading, the bearing capacities in the sub-grade/road foundation build in soft grounds deteriorates with changes in moisture content, especially in peat swamps environments, coastal marine clays and even on high grounds with sedimentary pockets of fines of high organic content, silt and kaolin clays. With commercial exploit by truckers to overload zealously on the one hand, and a deterioration of sub-grade due to changes in water table/moisture content as a result of climate change, ferocious land clearing for development and flash floods, the road structure is subjected to enormous fatigue stresses, resulting in extensive pavement cracking. Aggravating the damage further is the subs

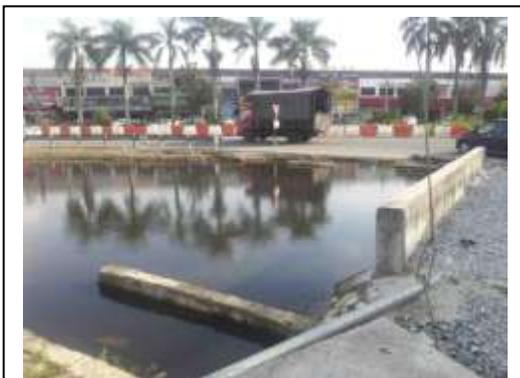
Roads under constant soaking conditions

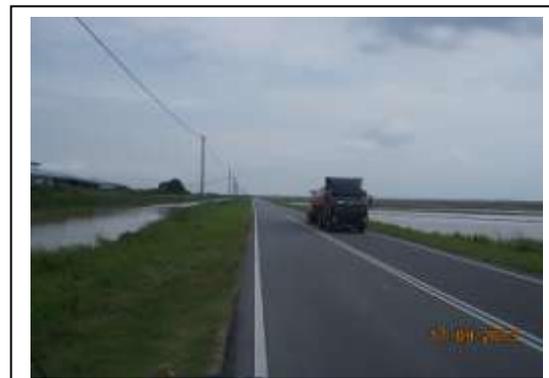
Flooding is common place in the granaries

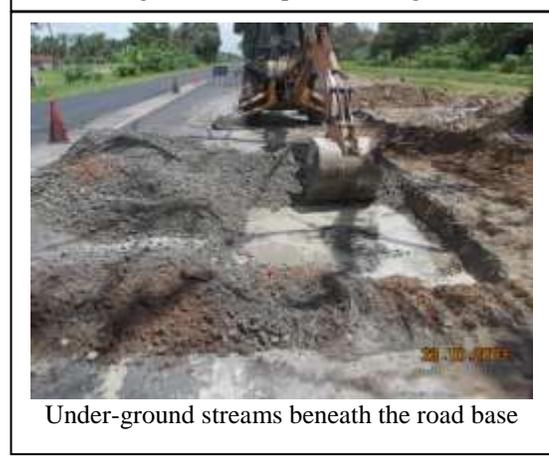
Under-ground streams beneath the road base

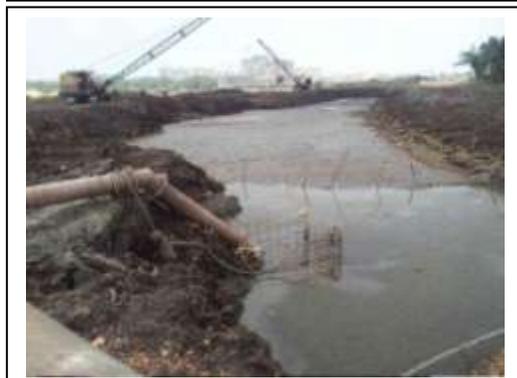
Peat Swamp Environment

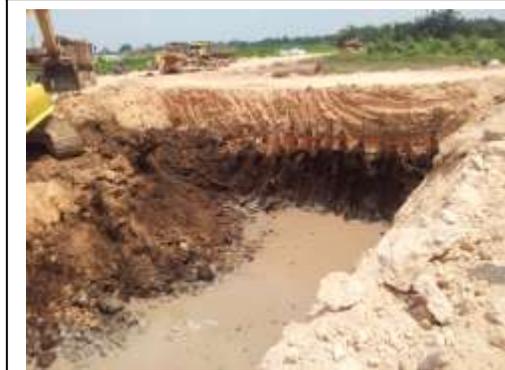
2 m over burden as temporary access

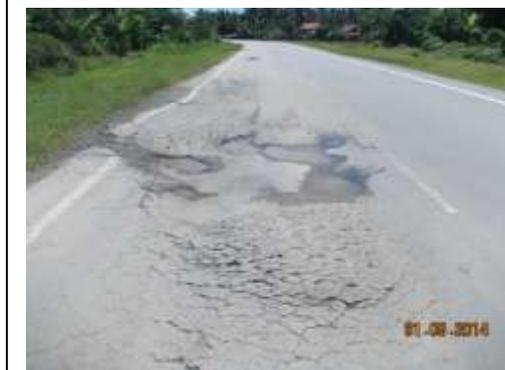
Crocodile cracks

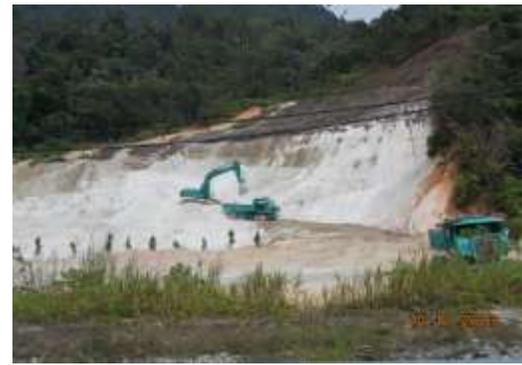
'Koalin' clay formation

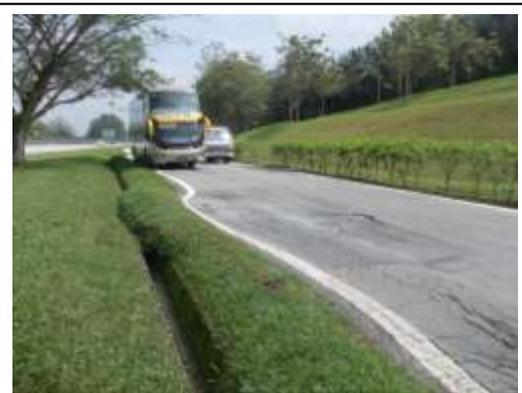
Vertical deformation in cut ground

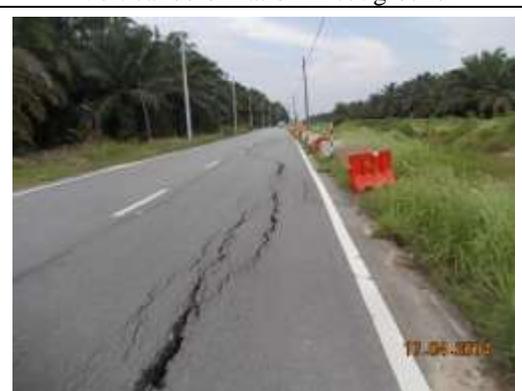
Soil subsidence and lateral movements

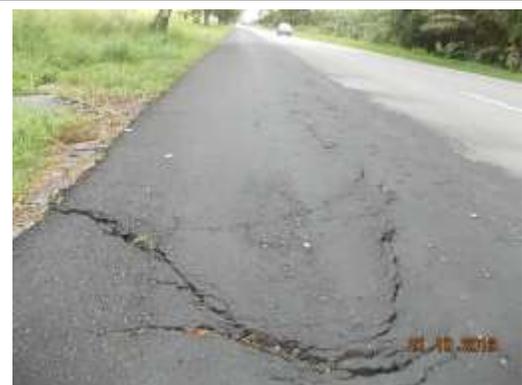
V-shape cracks due to horizontal tensile strain

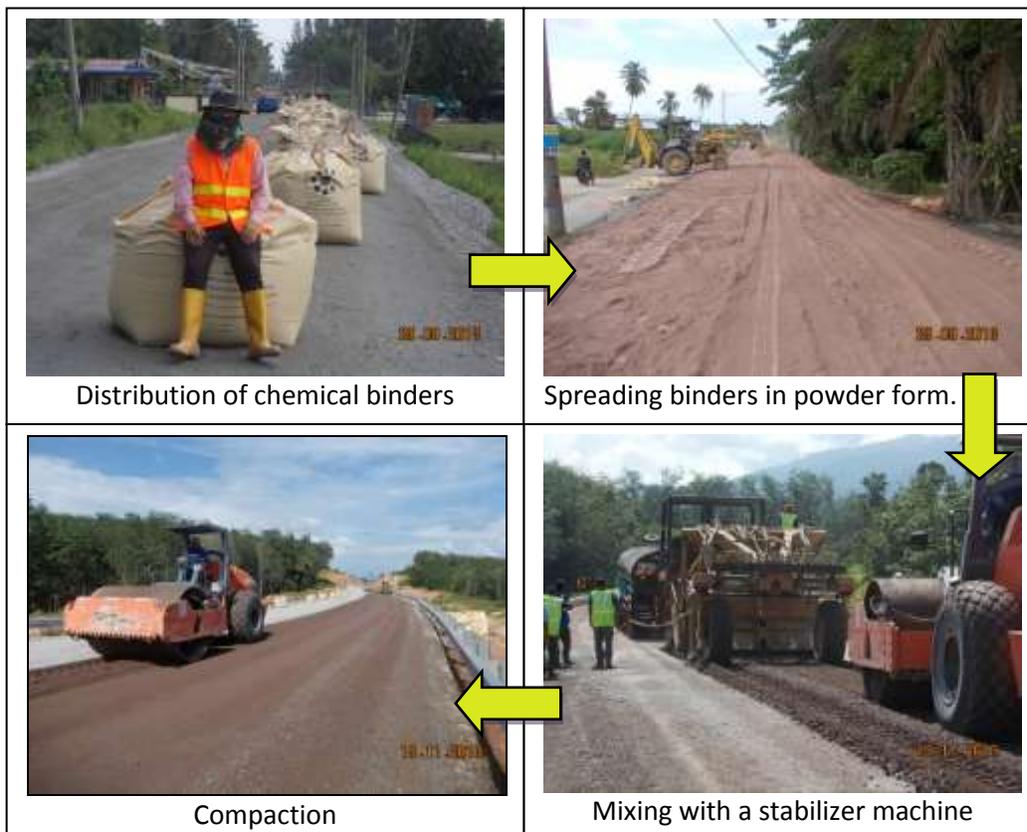
A **quick repair approach** for damaged roads in soft grounds using cold in-situ chemical soil stabilization re-cycling process is used successfully in Perak PWD, Malaysia. The damaged road surface is 'milled' so as to expose the underlying road base material to be strengthened. Spreading (2%-3% dosage) of a polymer modified cementitious chemical binder in powder form unto the exposed road base and using a stabilizer machine to mix the chemical admixture homogenously into the road base, and compact to 95% maximum dry density. A 300 mm thick stabilized road base is immediately protected (within one day) with a layer of asphaltic concrete binder course, and the road opened to traffic. Production achievable is 1 km x 3.5m width lane per day per stabilizer machine. There is no disruption to on-going traffic on busy roads during construction, with one lane closed for construction, and contra traffic flow on the open lane. Traffic management, safety cones and sign boards to caution public road users were deployed. The 7-day in-situ California Bearing Ratio testing achievable is 80% < CBR < 250%.

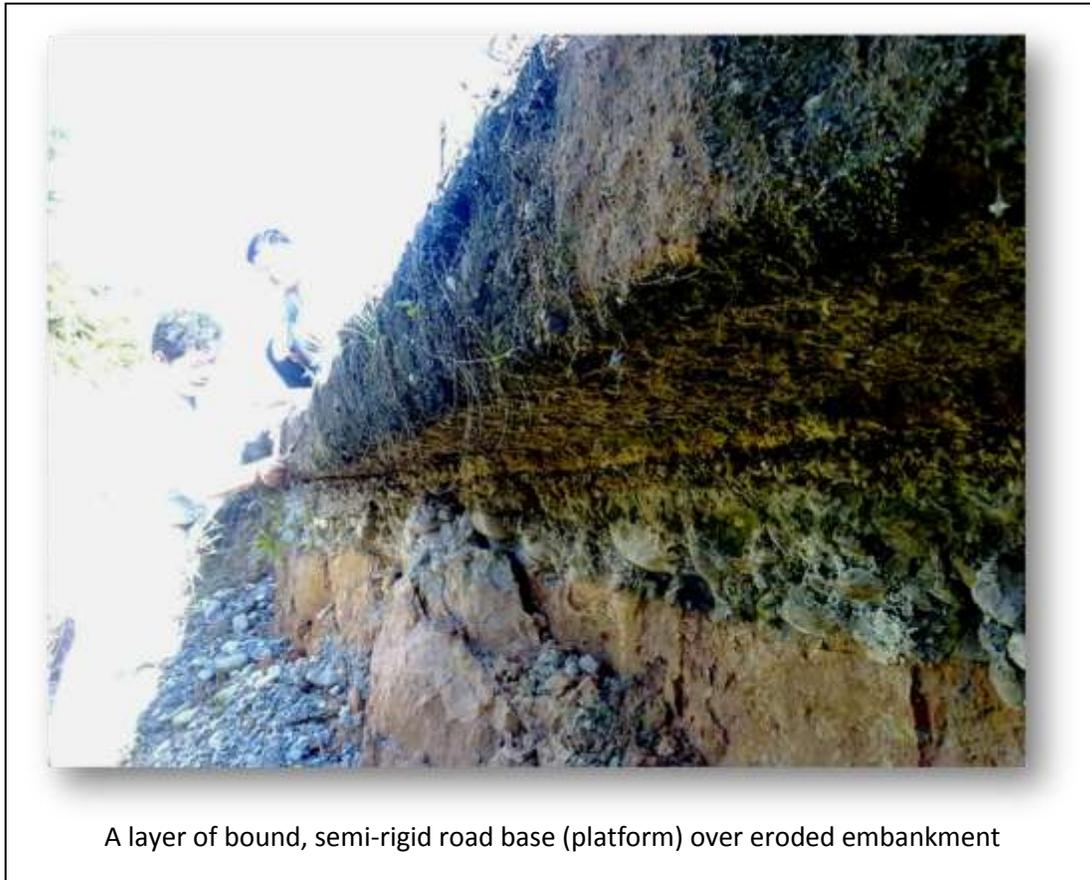
The purpose of chemical soil stabilization is to add and mix chemical admixtures homogenously into the soil to bind up the fines into ‘granular’ so as to improve and maintain its material strength/bearing capacities, even under long term soaking conditions.

And by applying compaction onto the formation and transforming it into a layer of bound, semi-rigid platform or raft, ‘floating’ over underlying soft grounds.

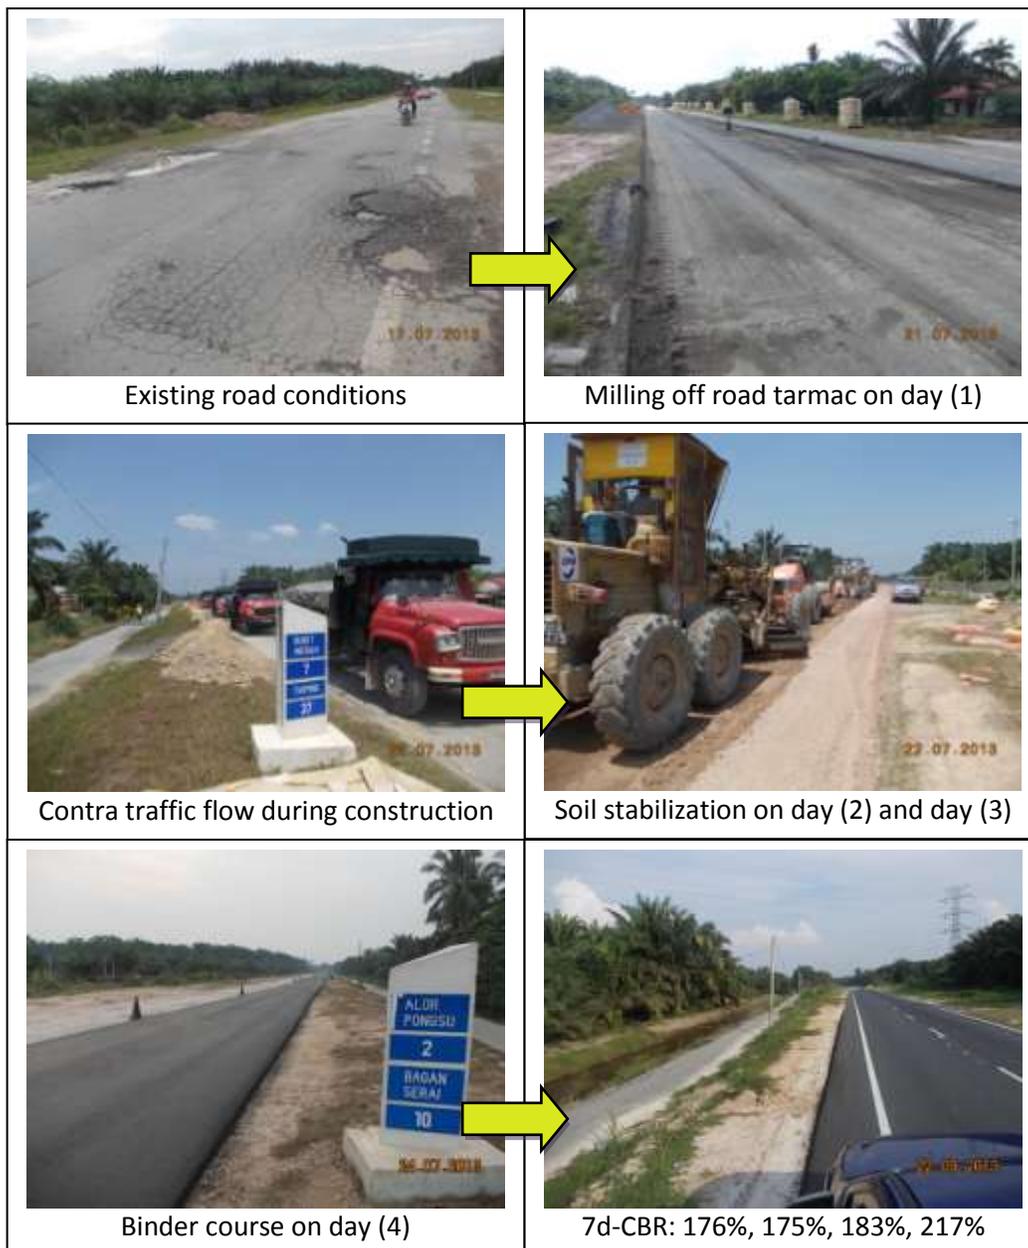
CASE STUDY No 1: Jalan Alor Pongsu, Kerian, Perak, Malaysia

This is a newly completed road in December, 2012 measuring 7km (L) x 8m (W) with over-laden trucks carrying earth and aggregates from Bukit Merah to nearby construction sites.

Despite the immense traffic plying this road (ADT: 70 truck trips per hour one way), road base strengthening/stabilization works was completed in two (2) working days for 650mL x 8mW (Phase I - July 2013) and also in two (2) working days for 600mL x 8mW (Phase II - June 2014)

One lane is closed for construction, while contra traffic flow is channeled into the other lane with no disruption to on-going traffic flow. The construction process involved 1. Milling off existing damaged road tarmac to expose underlying crusher run road base. 2. Spread and mix chemical binders homogeneous into existing 300 mm thick road base to be strengthened. 3. Compact and grade to finish levels. 4. Lay a layer of asphaltic binder course and open road to traffic.

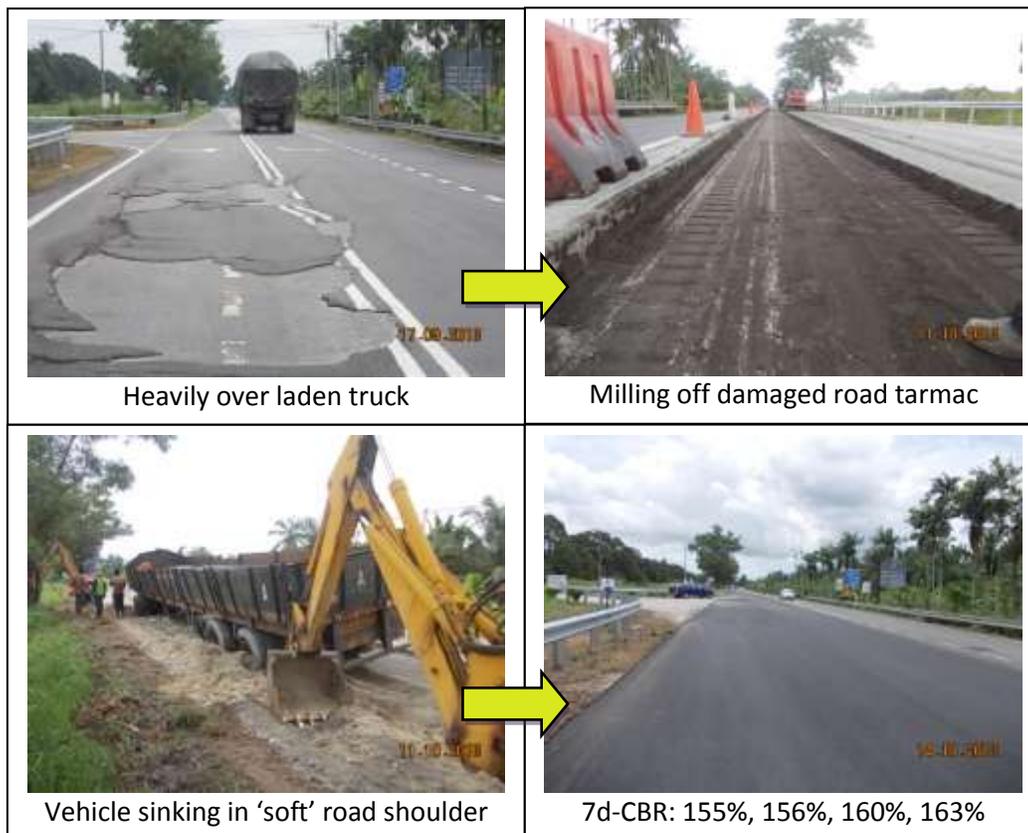
CASE STUDY No 2: Jalan Trans Perak, Perak, Malaysia

The road was built in the 80's and up-graded and widened in the 90's. The road is located in the granaries, with constant flooding for rice cultivation. Differential settlement occurred between 'old and new' road sections, and the road is undulating along the longitudinal profile due to soil subsidence as a result of high traffic volume of heavy laden trucks plying their trades carrying grains and oil palm produce. Road base strengthening in the 'new' road section was completed in two (2) working days in November 2013 (Phase I - 1200mL x 4.5mW) and also in two (2) working days in June 2014 (Phase II - 2200mL x 3.5mW), by recycling the exposed underlying 300 mm thick crusher run.

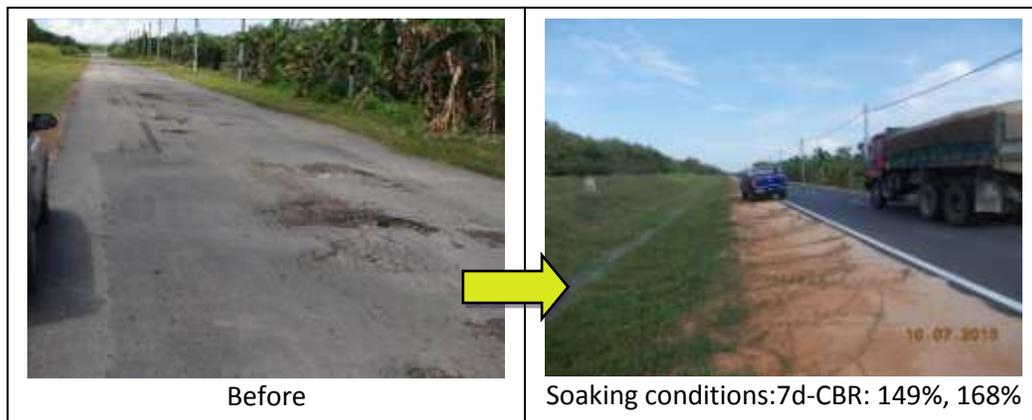
CASE STUDY No 3: Jalan Sungai Tiang (A123), Teluk Intan, Perak, Malaysia

Due to climate change and rising tidal levels, the road formation is located below the sea level; and water is stagnant in the roadside drains all year round. A new layer of 300 mm thick crusher run was placed on top of the damaged road over stretch of road measuring 400mL x 8mW. Road base strengthening was completed on two (2) working days on 21st and 22nd December 2012.

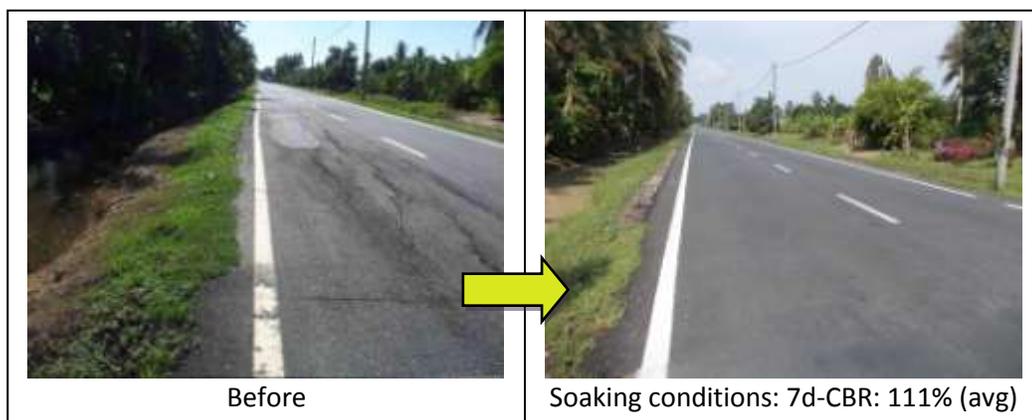
CASE STUDY No 4: Jalan Tanjong Piandang, (A104), Parit Buntar, Perak, Malaysia

This is a busy road located in the granaries, with irrigation canals running on each side. Road base strengthening on 300 mm thick crusher run was carried out over a stretch of road measuring 400mL x 8mW, and completed in November 2012, with no disruption to traffic during construction.

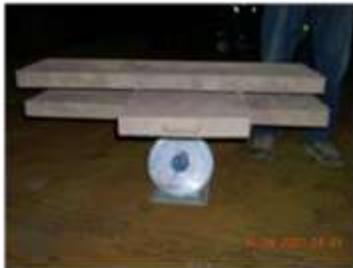
Spreading Rate Check

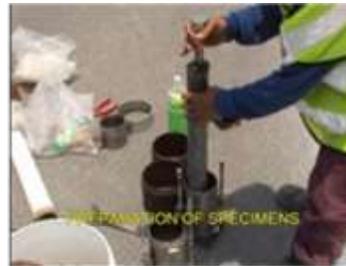
Preparation of Specimens

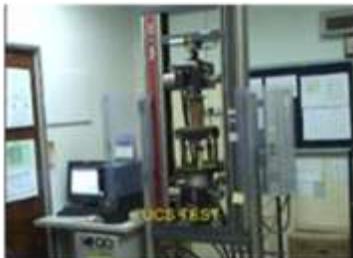
UCS Test

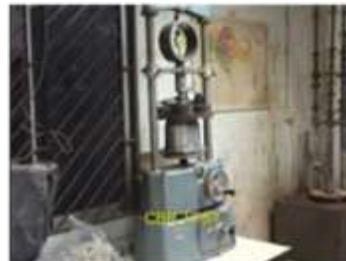
CBR Test

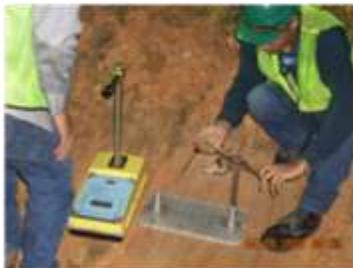
Nuclear Density Test

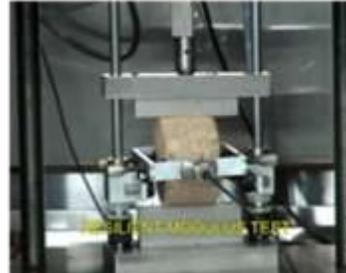
Resilient Modulus Test
